*Waterville Valley Resort LLC
1 Ski Area Road
Waterville Valley, NH 03215
03/30/12 USEPA Inspection*

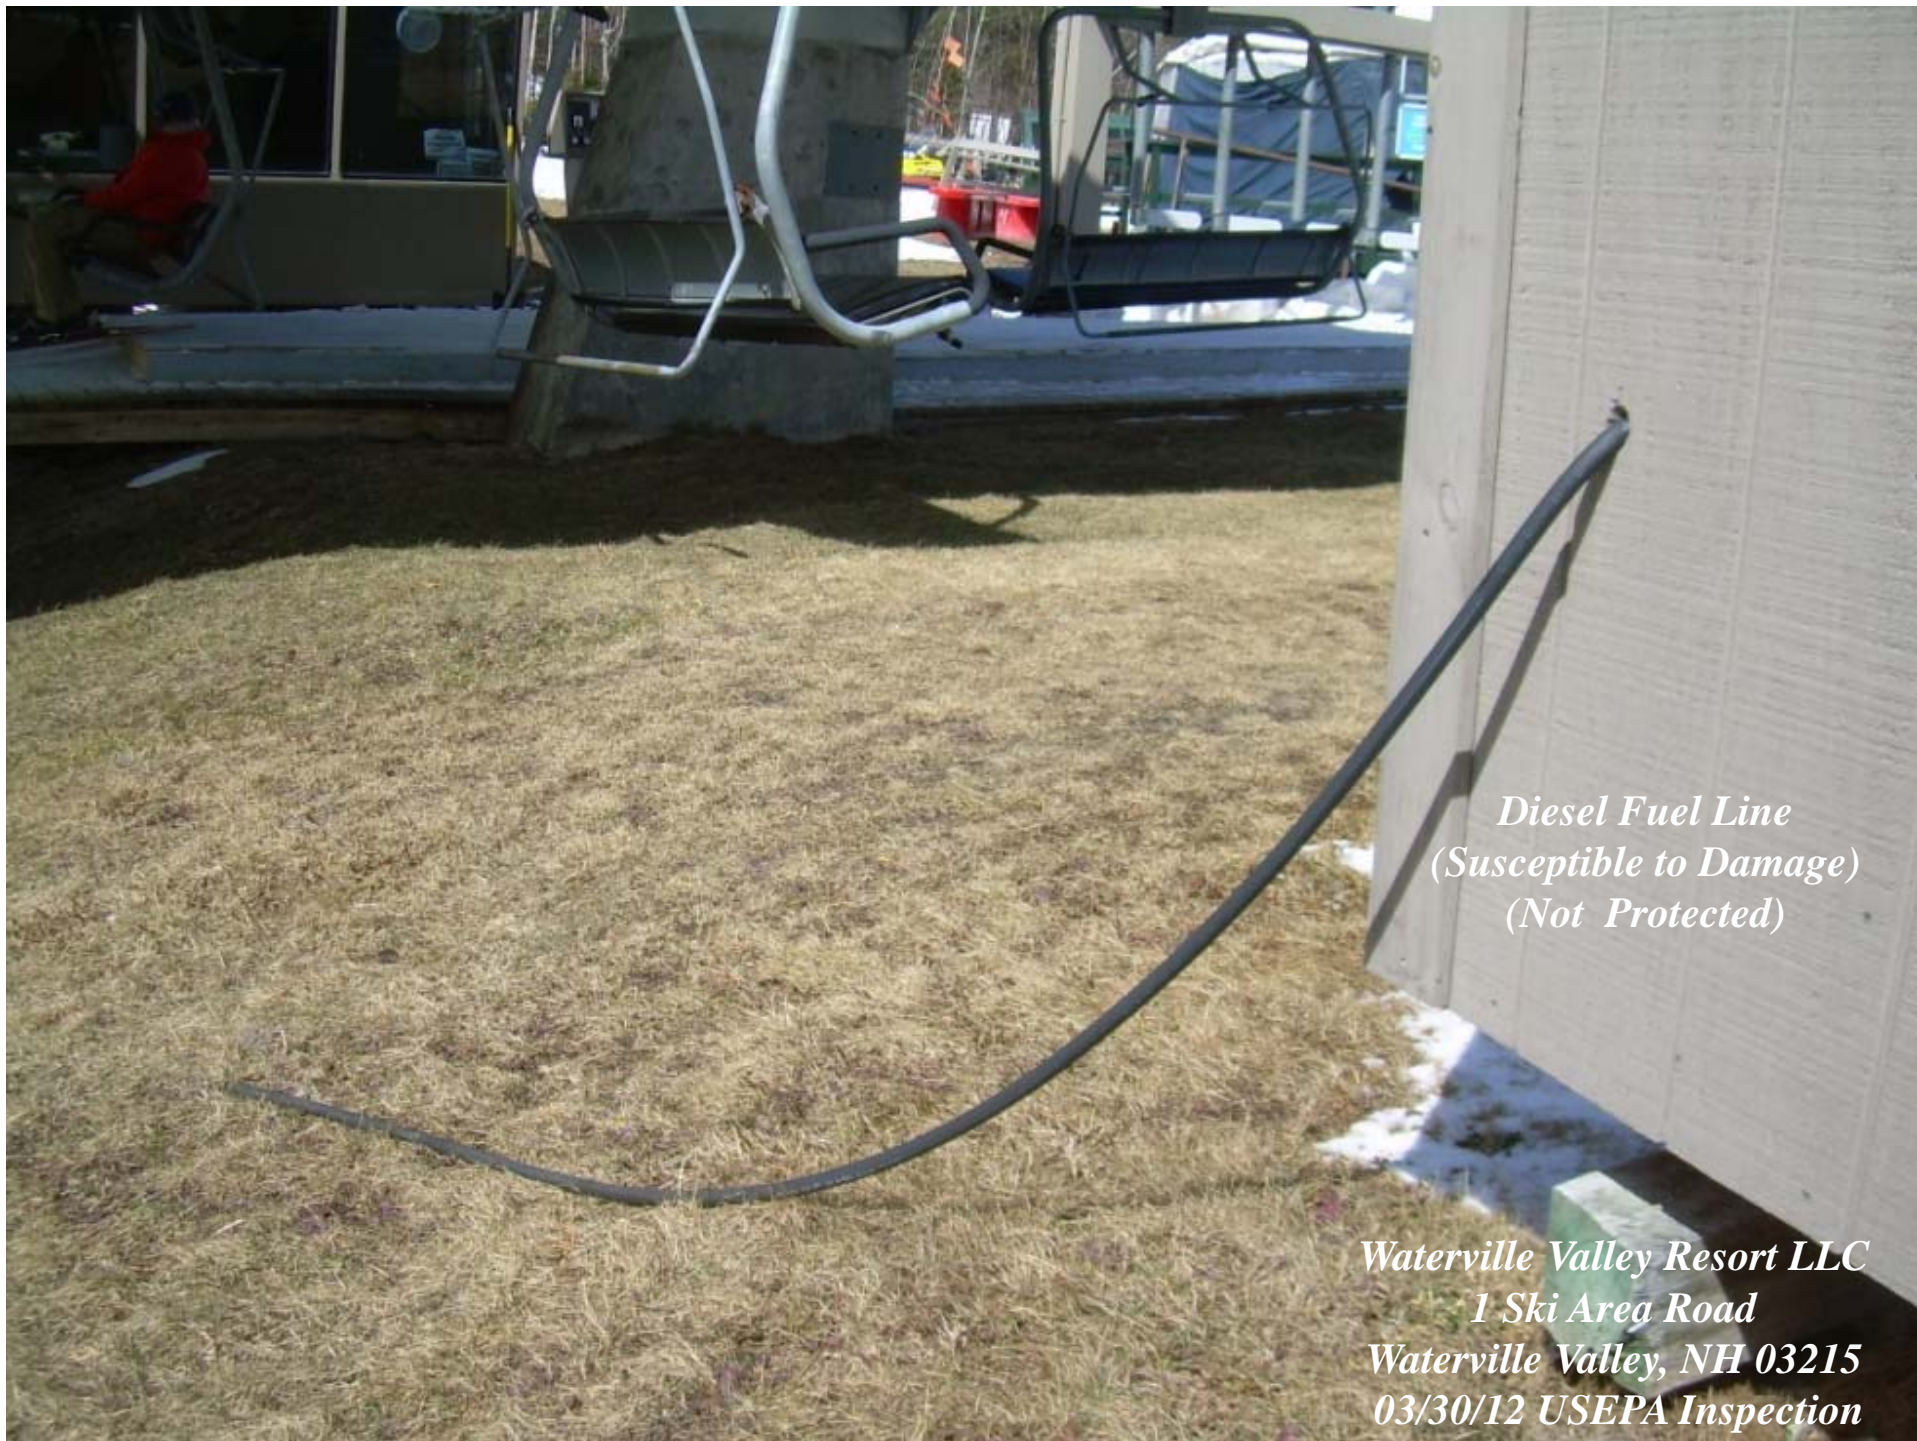
*Diesel Fuel Line
(Susceptible to Damage)
(Not Protected)*

*Mobile Refueler/Snow Cat
300- Gallon Oil Tank
&
Secondary Containment Area*

*Debris in Containment Area
(Clean Regularly)*

*Drain
(Not Capped)
(Install Drain Plug)*

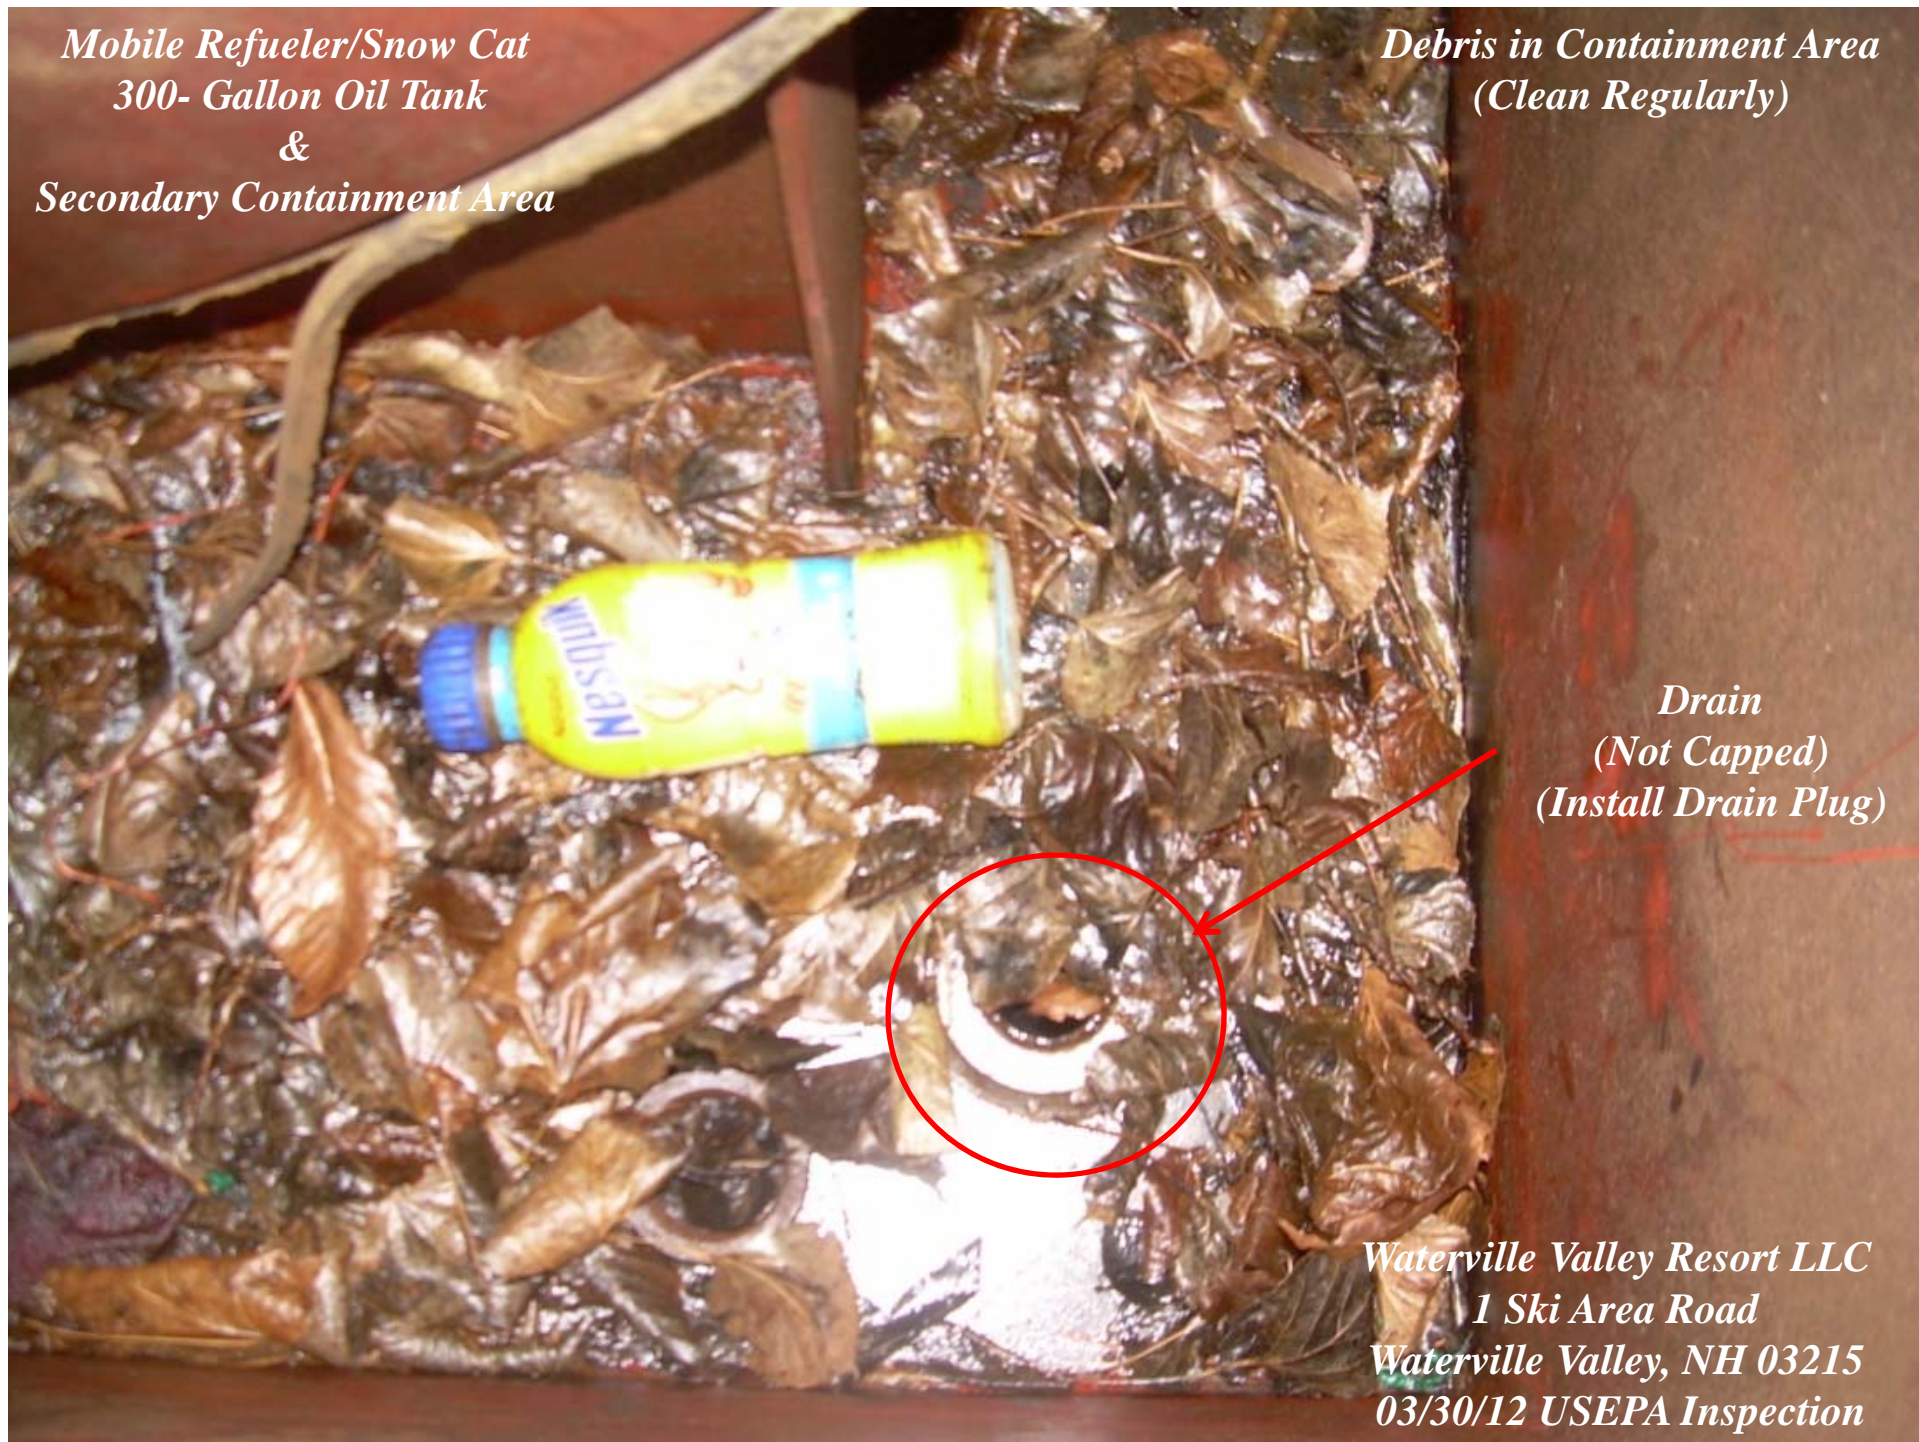
*Mobile Refueler/Snow Cat
300-Gallon Oil Tank Onboard*

*Water w/Oil Leak from Oil Tank's Secondary Containment Area
(Inspect and Document Liquid for Oil Sheen Prior to Discharge)*

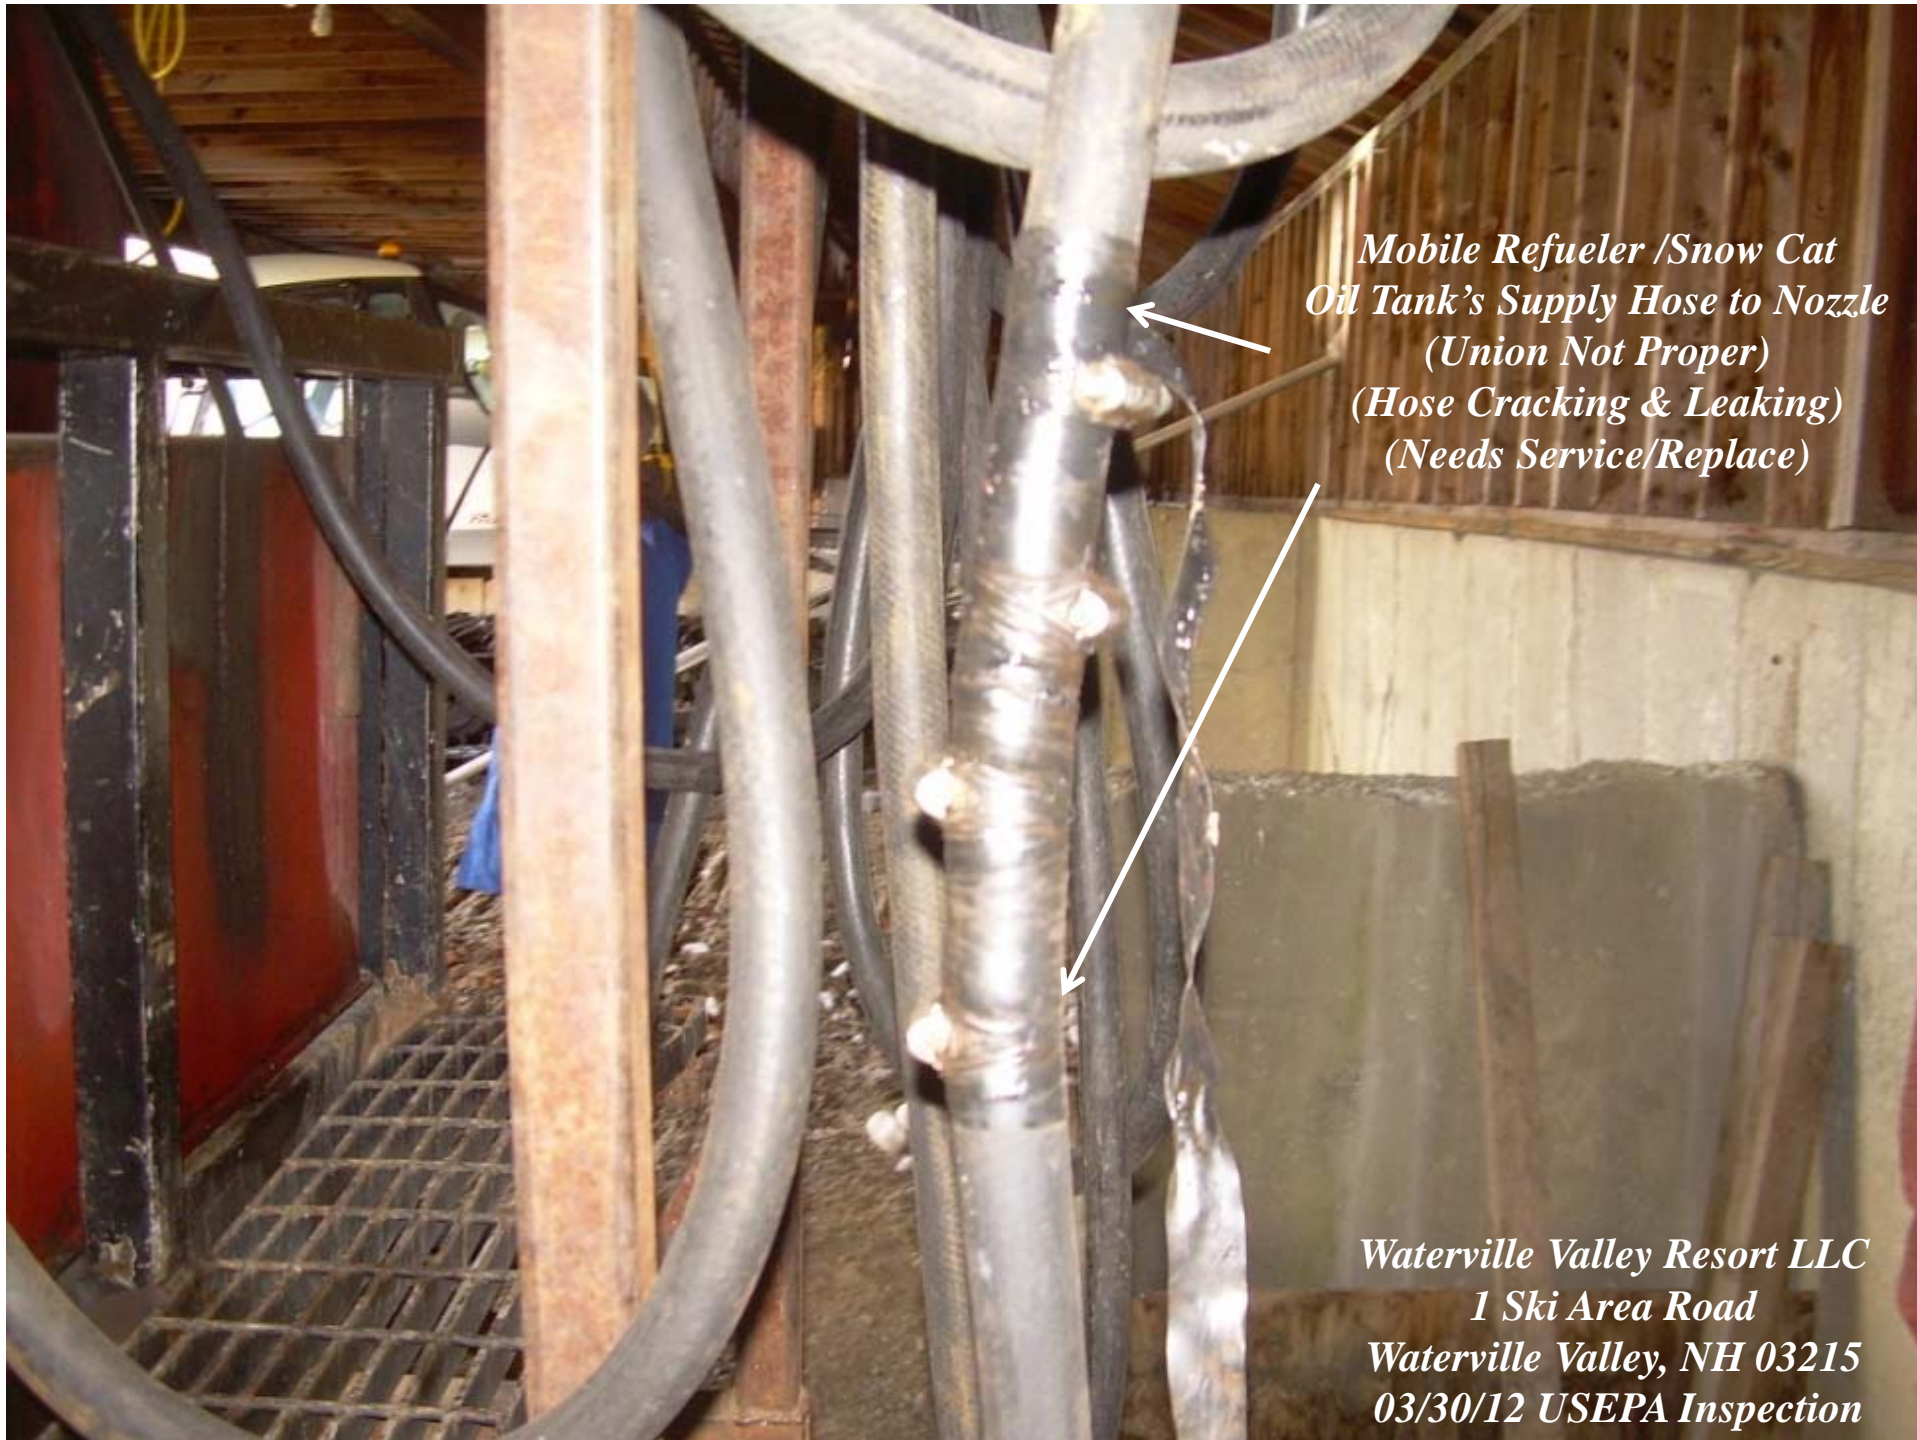
*Mobile Refueler /Snow Cat
Oil Tank's Supply Hose to Nozzle
(Union Not Proper)
(Hose Cracking & Leaking)
(Needs Service/Replace)*

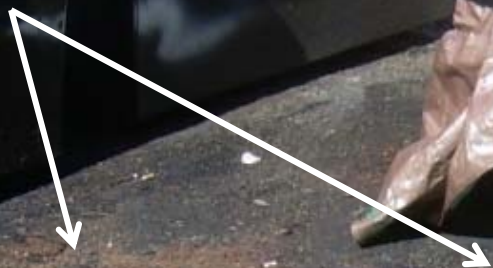
*Food Oil Waste Containers
(No Secondary Containment)
(Oil Spillage on Ground)
(Clean)*
